DDAS Accident Report

Report date: 31/01/2008	Accident number: 542
Accident time: 11:10	Accident Date: 09/01/2007
Where it occurred: Ar Rafiyah District, Basrah Province, Southern Iraq	Country: Iraq
Primary cause: Inadequate training (?)	Secondary cause: Field control inadequacy (?)
Class: Handling accident	Date of main report: 09/01/2007
ID original source: BOI 001 091007	Name of source: [Name removed]
Organisation: [Name removed]	
Mine/device: BLU-61A/B	Ground condition: dry/dusty
Date record created:	Date last modified: 31/01/2008
No of victims: 2	No of documents: 2

SUBJECT: BOARD OF INQUIRY REPORT

FOR [Demining group] UXO ACCIDENT IN AR RAFIYAH DISTRICT, SOUTHERN IRAQ, 09 January 2007

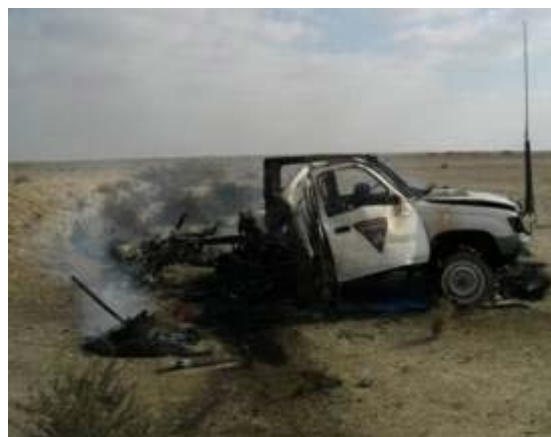
8.2 The vehicle (Toyota Hilux) had been destroyed by the effects of both explosive detonation(s) and a subsequent fire. The cab's roof was found 50 metres SW of the vehicle on a bearing of 188°.

[One side of the pick-up, showing how the load bay (bed) has been destroyed.]

8.3 The bed of the vehicle was gone. Parts of the side panels were found as far as 100 metres from the vehicle.

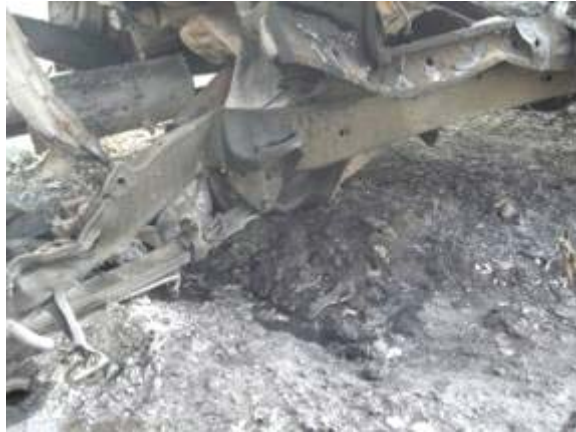
8.4 [Victim No.1]'s remains lay on the driver's side of the vehicle close to the left rear wheel. The vehicle tailgate and part of the vehicle bed had been blown off and was covering the body. The part of the vehicle bed covering the remains was missing a section in the area corresponding to that directly behind the right corner of the cab and forward of the right rear wheel. The section of frame brace directly beneath this location had been cut, the ends indicating a detonation from above. Beneath this section was found a crater 56 cm in diameter and 9 cm deep. This also indicated a detonation from the same locality.

[The crater and damaged chassis of the vehicle.]

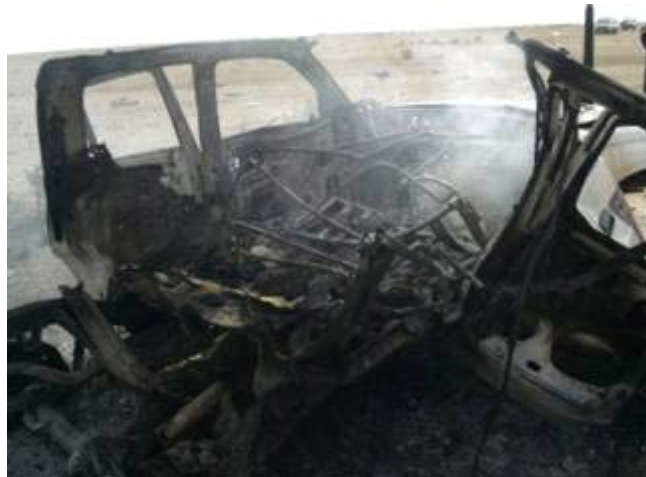
8.5 The direction of the debris field was 85% to the front and left (driver's side) of the vehicle. The farthest piece was the left tie-down rail at 104 metres. The other 10% was to the right (passenger's side) and consisted of a BLU 63 and one 125 mm Anti Tank projectile. One small piece of the vehicle bed was found 40 metres to the rear; also to the rear at 20 and 30 metres were the two halves of a BLU 63, these showed fragmentation damage and were coated with diesel fuel.

[The vehicle cab from behind.]

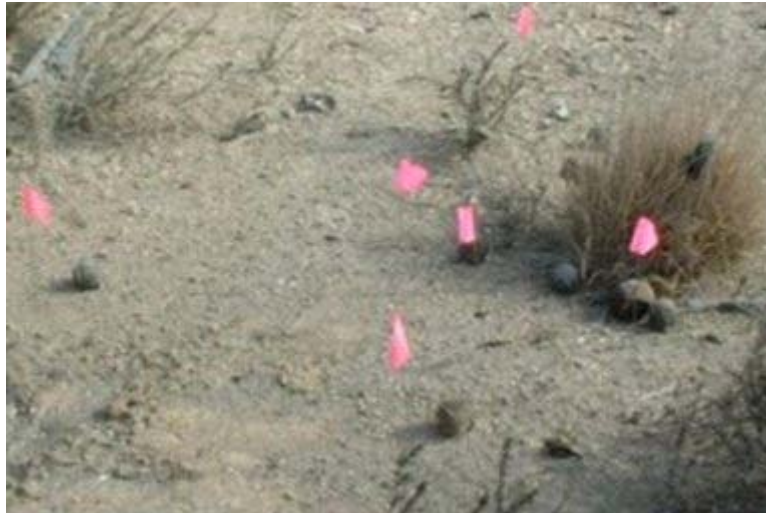
8.6 On the left side of the vehicle starting at approx two metres from it and extending in staggered line to approx 15 metres were 14 BLU 61 and 63 cluster munitions. These items did not show fragmentation damage nor were they coated with diesel fuel.

[Each red flag marks a BLU submunition on the ground surface, the BLU 61 is 99mm diameter and there appears to be one on the right, in between two smaller BLU 63s.]

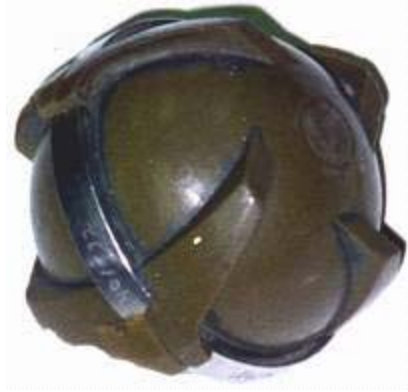
BLU-61A/B HE fragmentation/Incendiary

This is an aerial dispensed, spin-armed, impact-initiated, high explosive incendiary, anti-material, fragmentation bomb. It is detonated by an M219E1, all-ways acting (omni-directional) fuze. The bomb is painted olive drab without markings. Each hemisphere is made from a coined steel fragmentation liner, and an incendiary liner of zirconium-tin. The hemispheres are encased in a urethane plastic shell. The clamp ring is stainless steel.

Diameter 99mm 277g TNT/HMX Total weight 1 kg

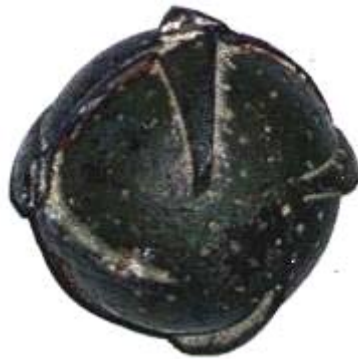
BLU-63 HE fragmentation

These are aerially dispensed, centrifugally armed, high-explosive fragmentation (HE-frag) bombs. The bombs comprise two hemispheres held together by a crimp ring. The BLU-63A and A/B are impact-fired.

Diameter 76mm HE content: 113g Cyclotol Total weight: 430g
